Atigaru Point No. 1 Well Plugging – 2009

Operations Summary

Atigaru Point Well No. 1

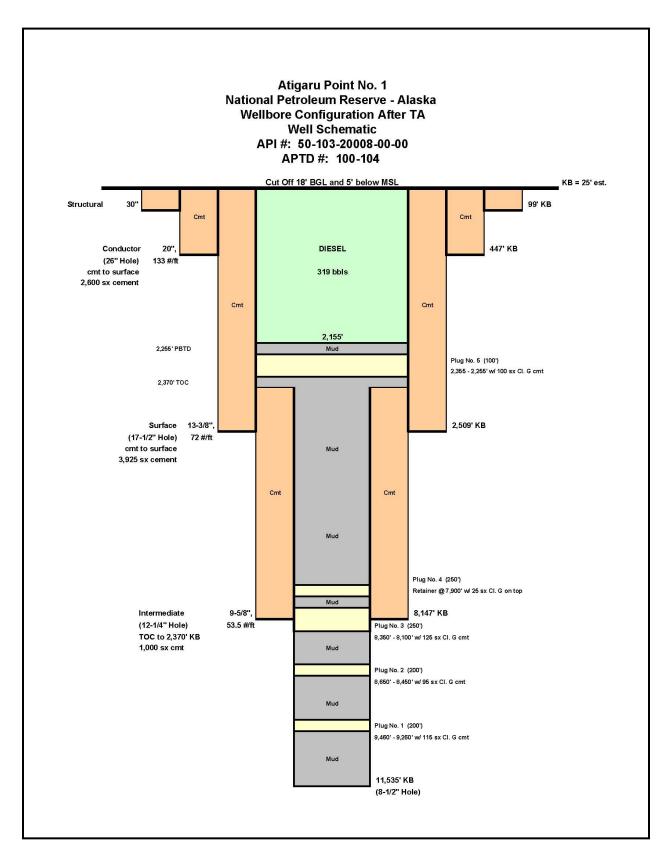
Figure 2: Atigaru Point No. 1 Well Configuration – July 2008 Status

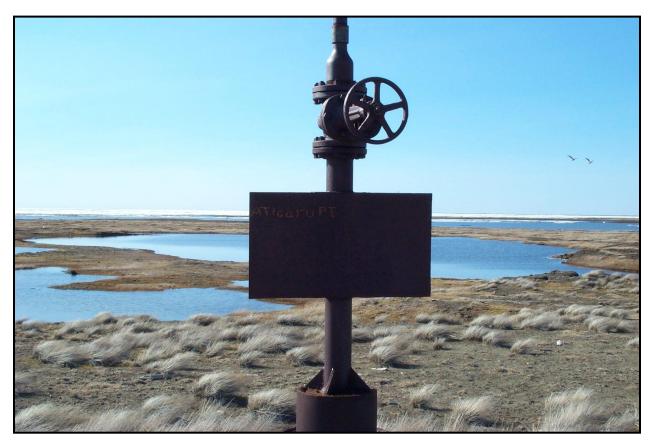
Figure 4: Atigaru Point No. 1 wellhead – July 2005 – Facing Southeast

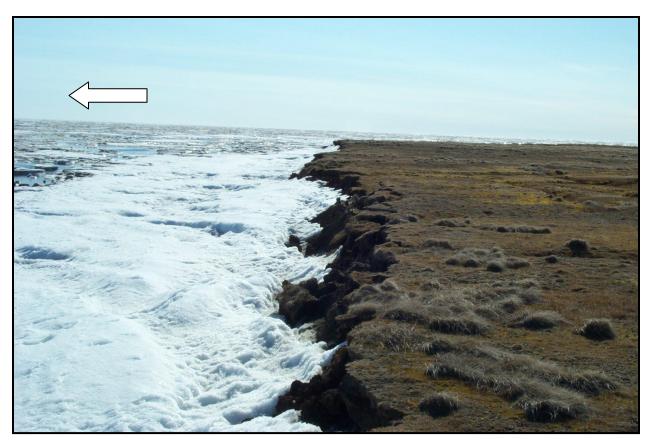
Figure 6: Coastal erosion on Beaufort Sea – July 2005 – Facing East

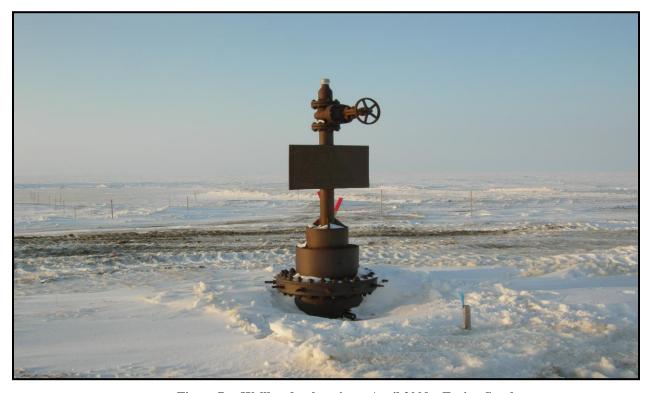
Figure 7: Wellhead at location – April 2009 – Facing South
